Intrepid Potash 2013 Carlsbad New Mexico

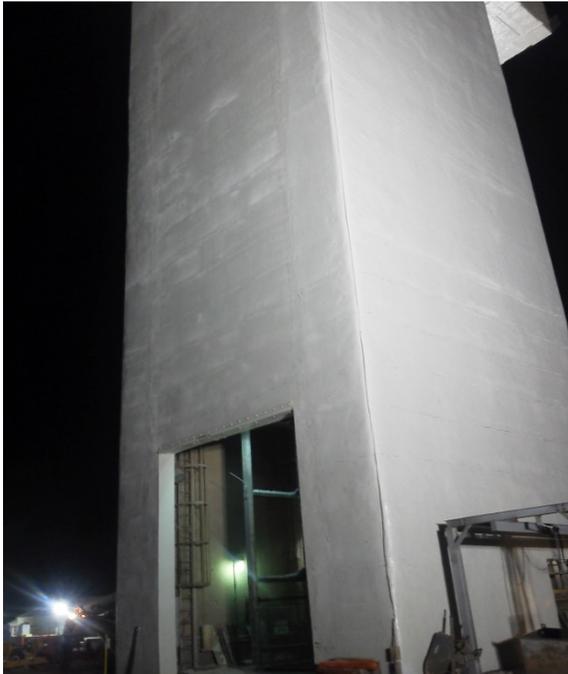
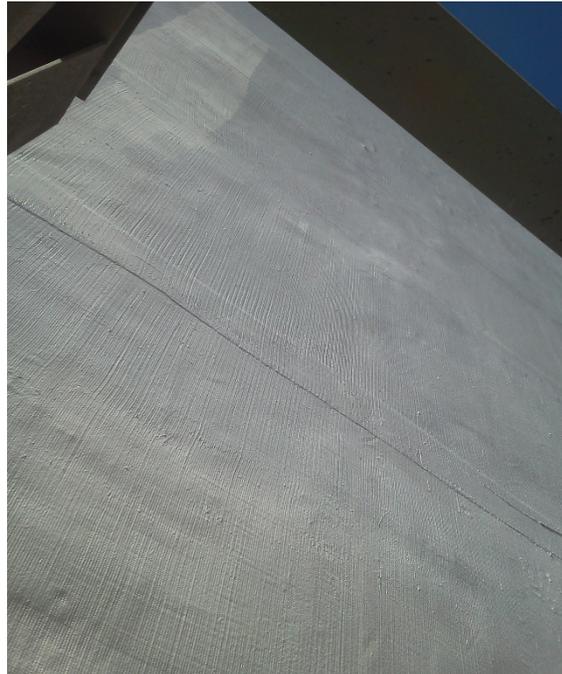
The following two pictures showcase the problems with the work on the FRP.
