Queen Mary Corrosion and Maxon Imaging

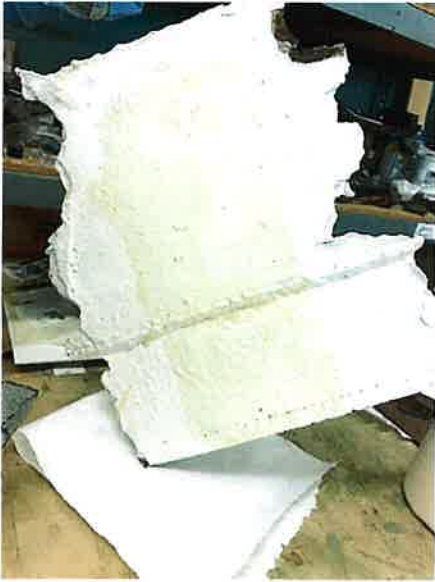
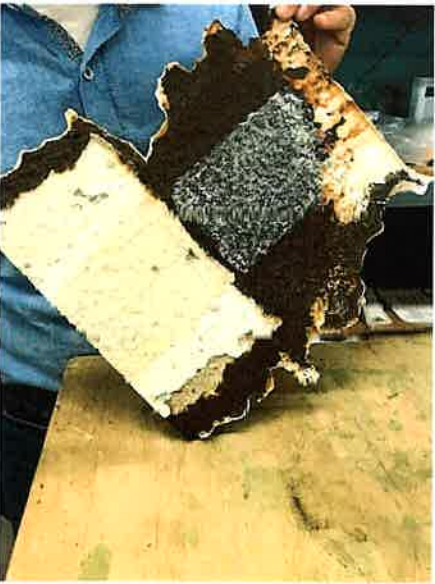
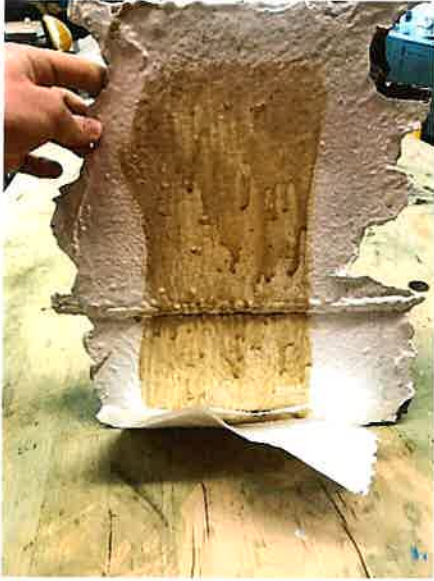
- Day 1 application of Maxon

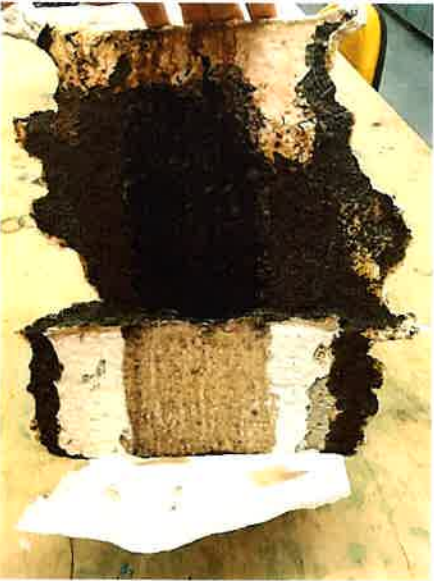
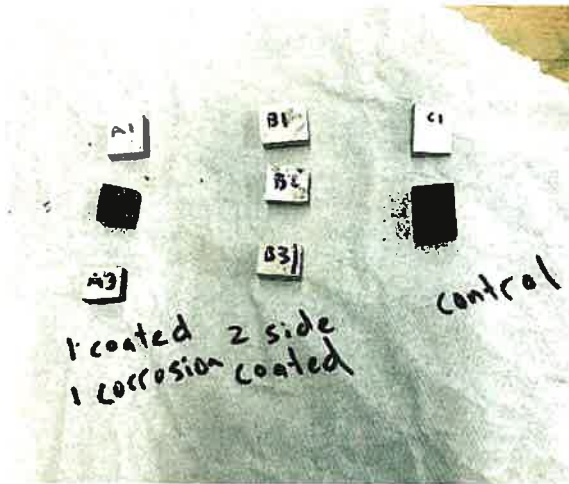
- Second application of Maxon. Two days after first application.

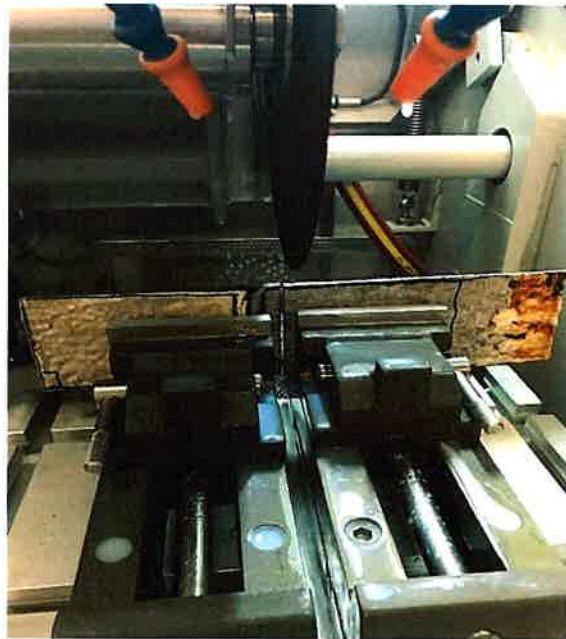
- Sample preparation from bulk sample
- "A" Series: 1 Maxon on paint coated face. 1 Corrosion face w/ Maxon coat.
- "B" Series: Both faces are painted, and have Maxon coat.
- "C" Series: Control sample. One side painted (no Maxon). One side rust (no Maxon).

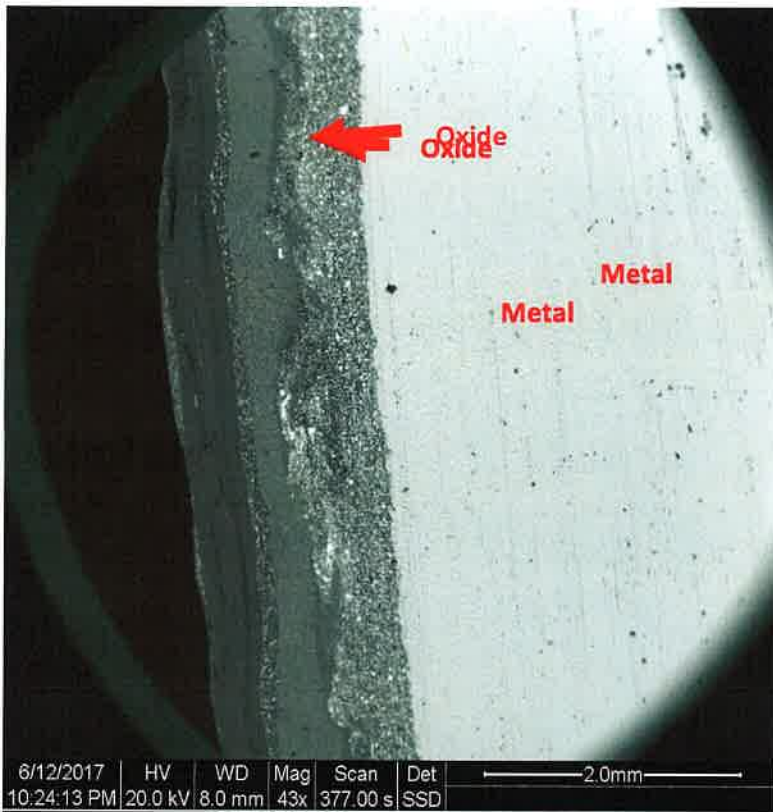
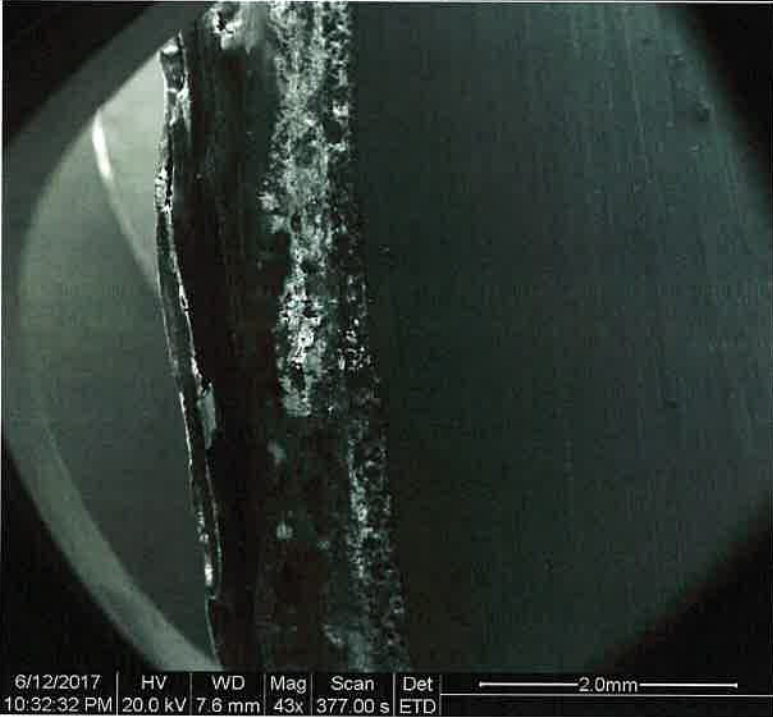
- C (control sample): ETD: shows surface topography and shape.
- SSD: Brighter the color, less electrically conductive so indicates oxide formation

- Need to conduct EDS analysis on the 3 unidentified regions to determine composition. Some oxide present in 2 of those layers at depth; less on surface.

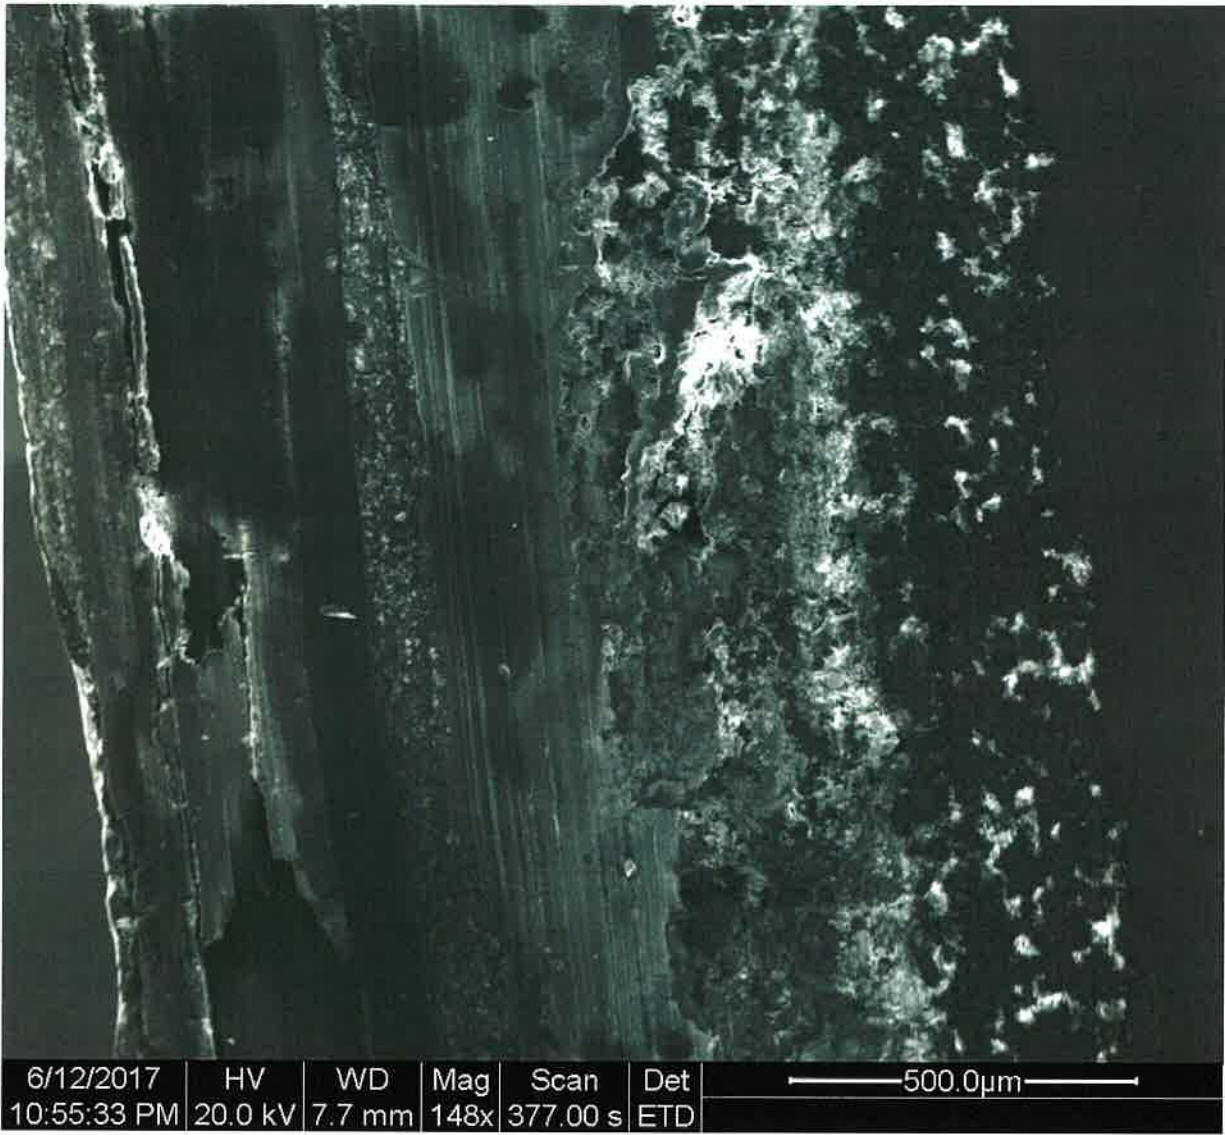
- C sample at same magnification but with ETD

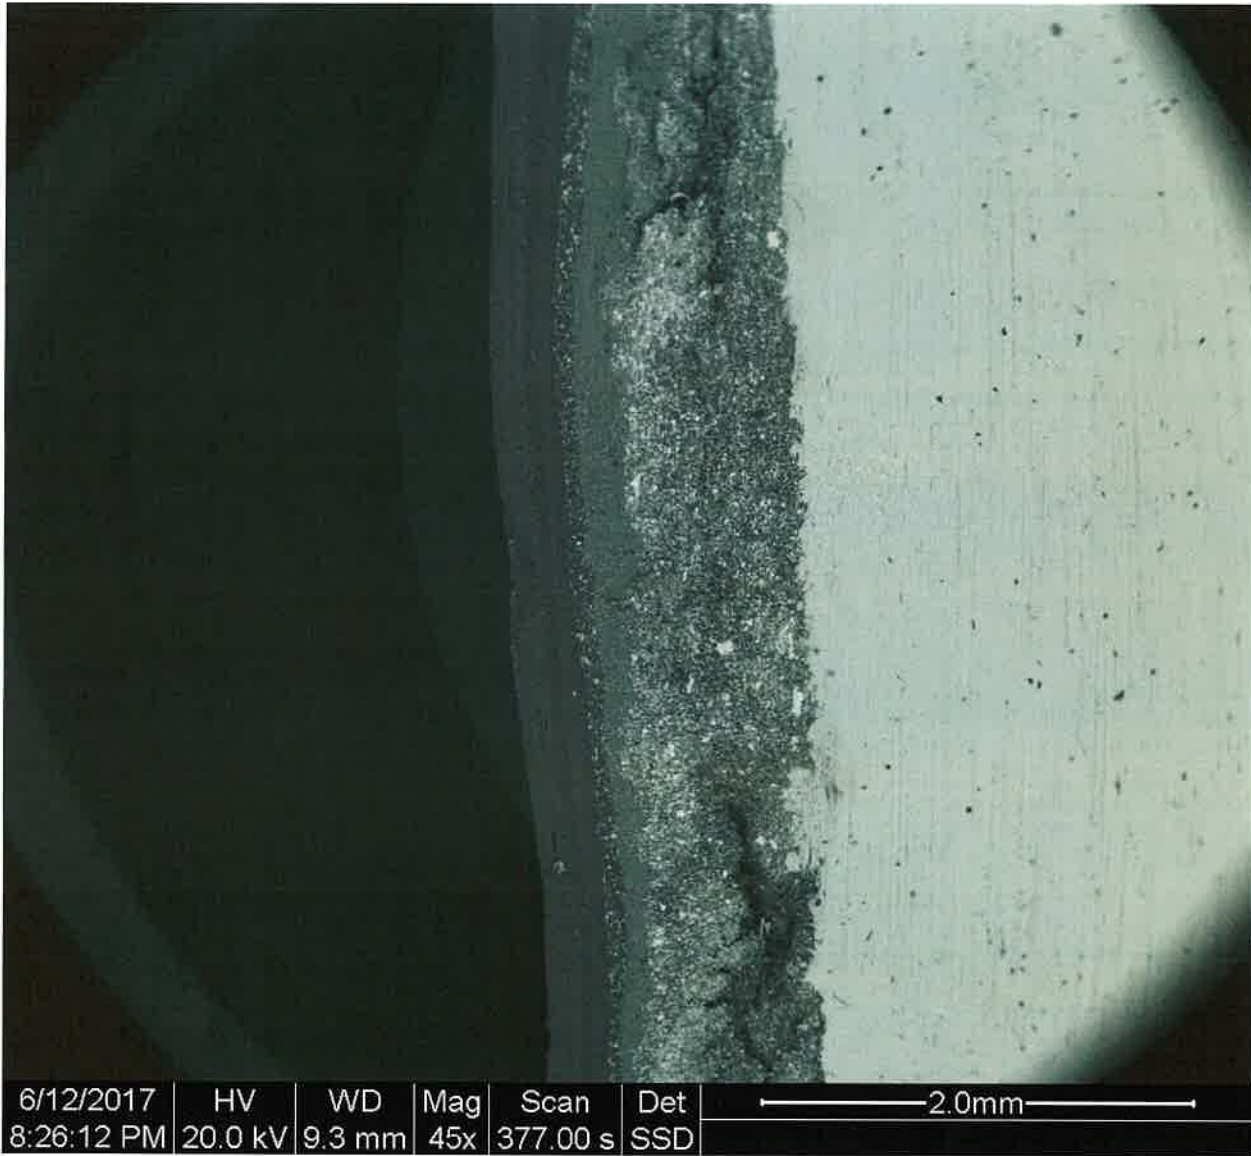
- A series sample – 1 Maxon on Oxide Face. 1 Maxon on Paint Face
- This sample does not have exterior oxide layer as C series did which was labeled "4".

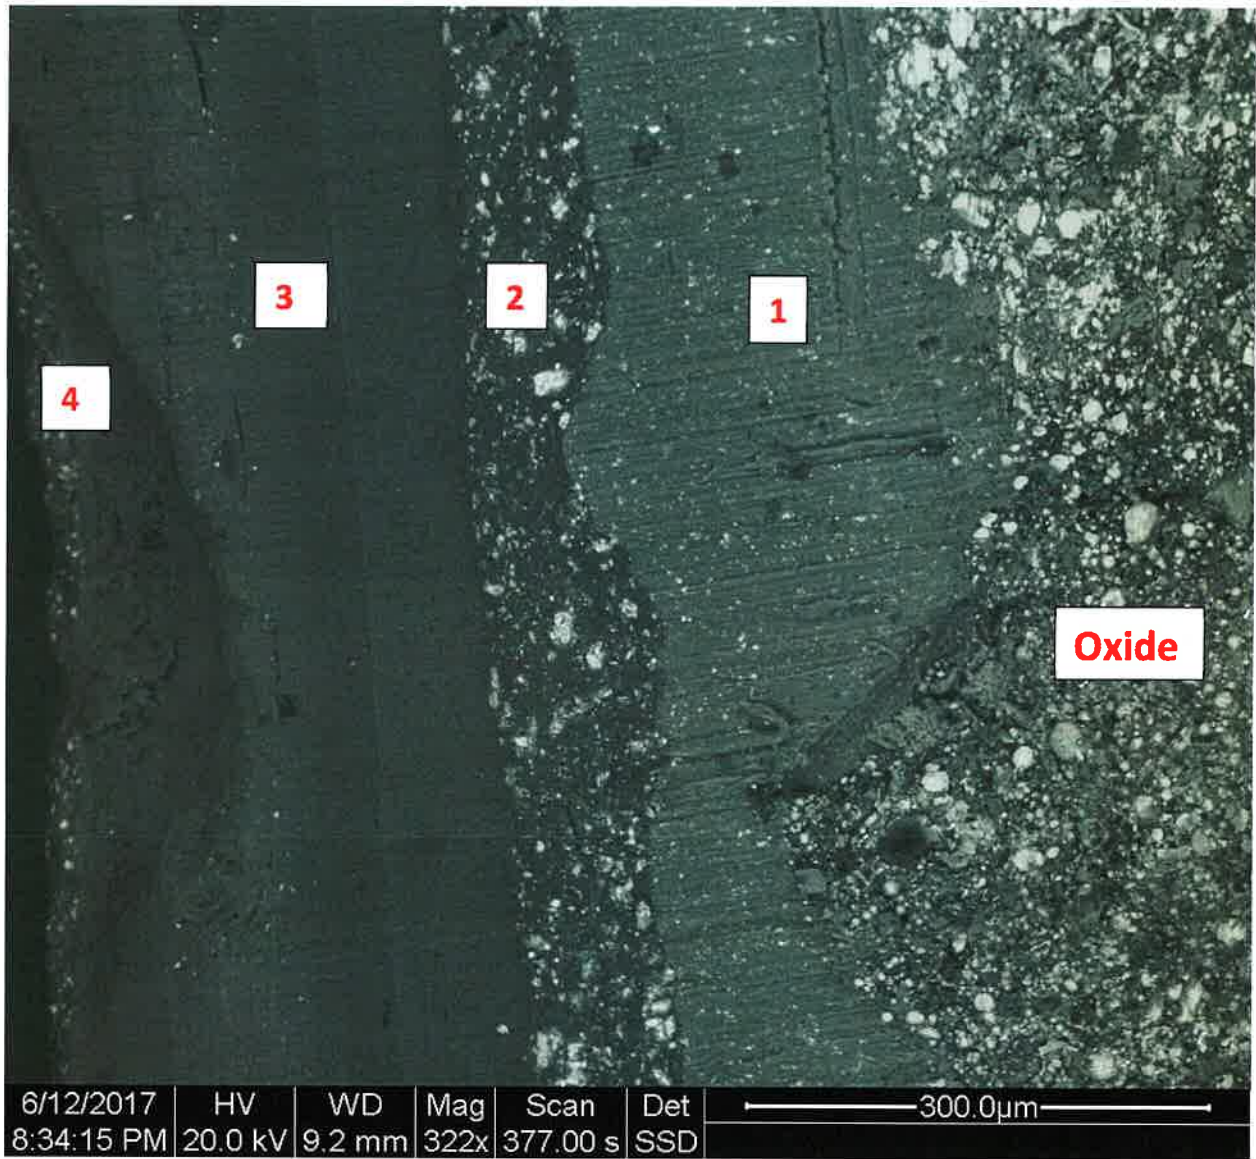
- "A" sample. Exterior oxide layer actually present at greater magnification, denoted by "4".

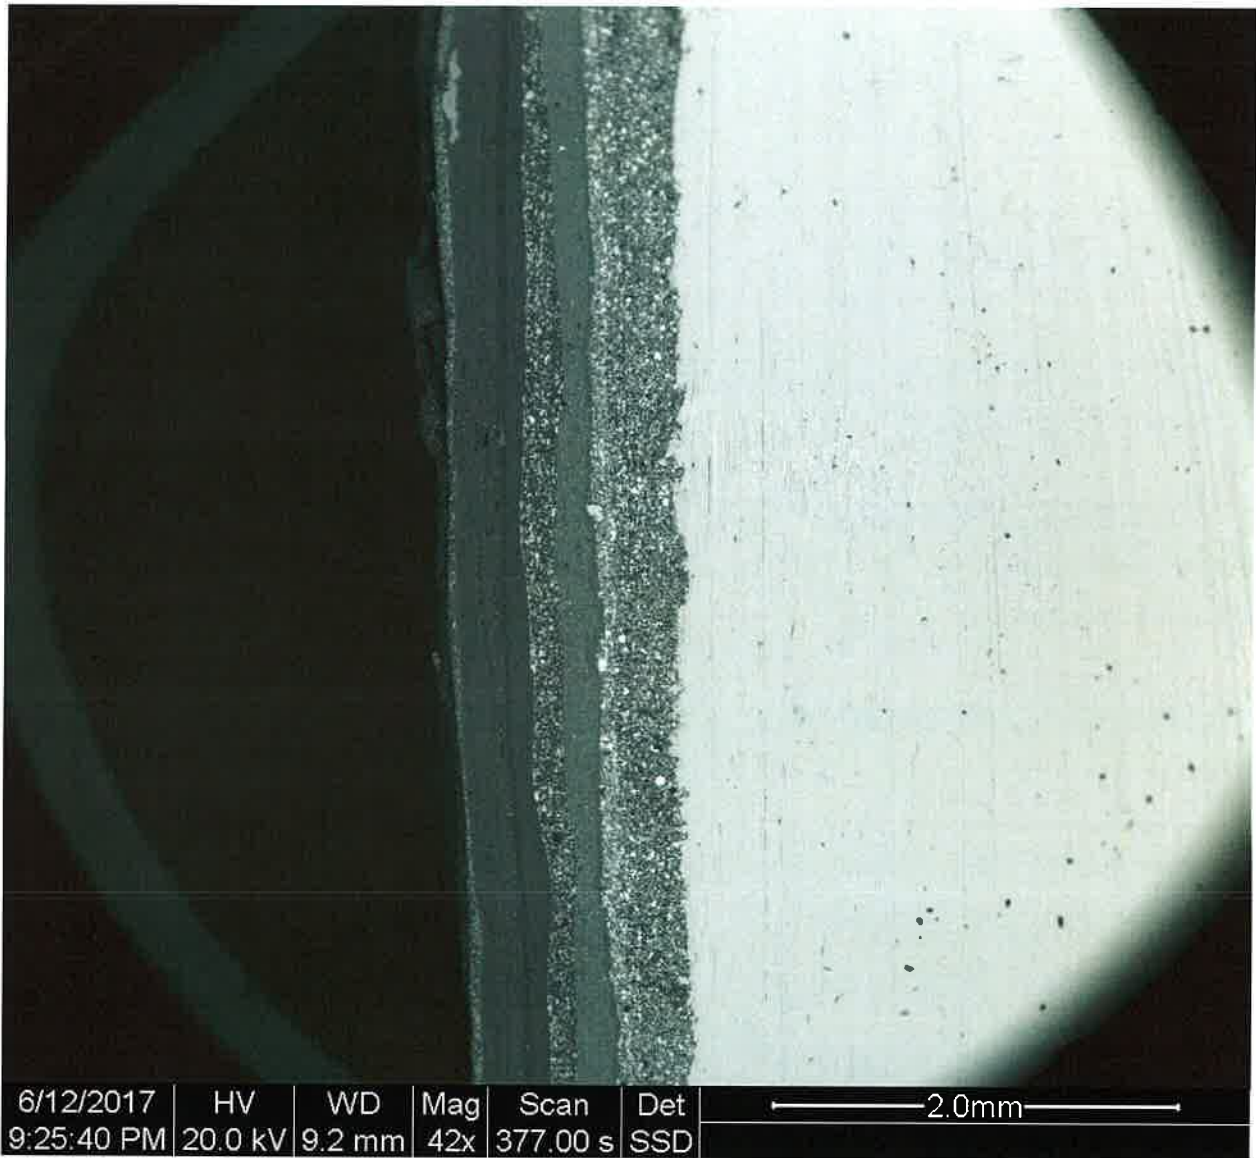
- B series sample – 2 Maxon on Paint Faces
- Thicker “2” region. Why?
- No exterior oxide likely due to paint layer.

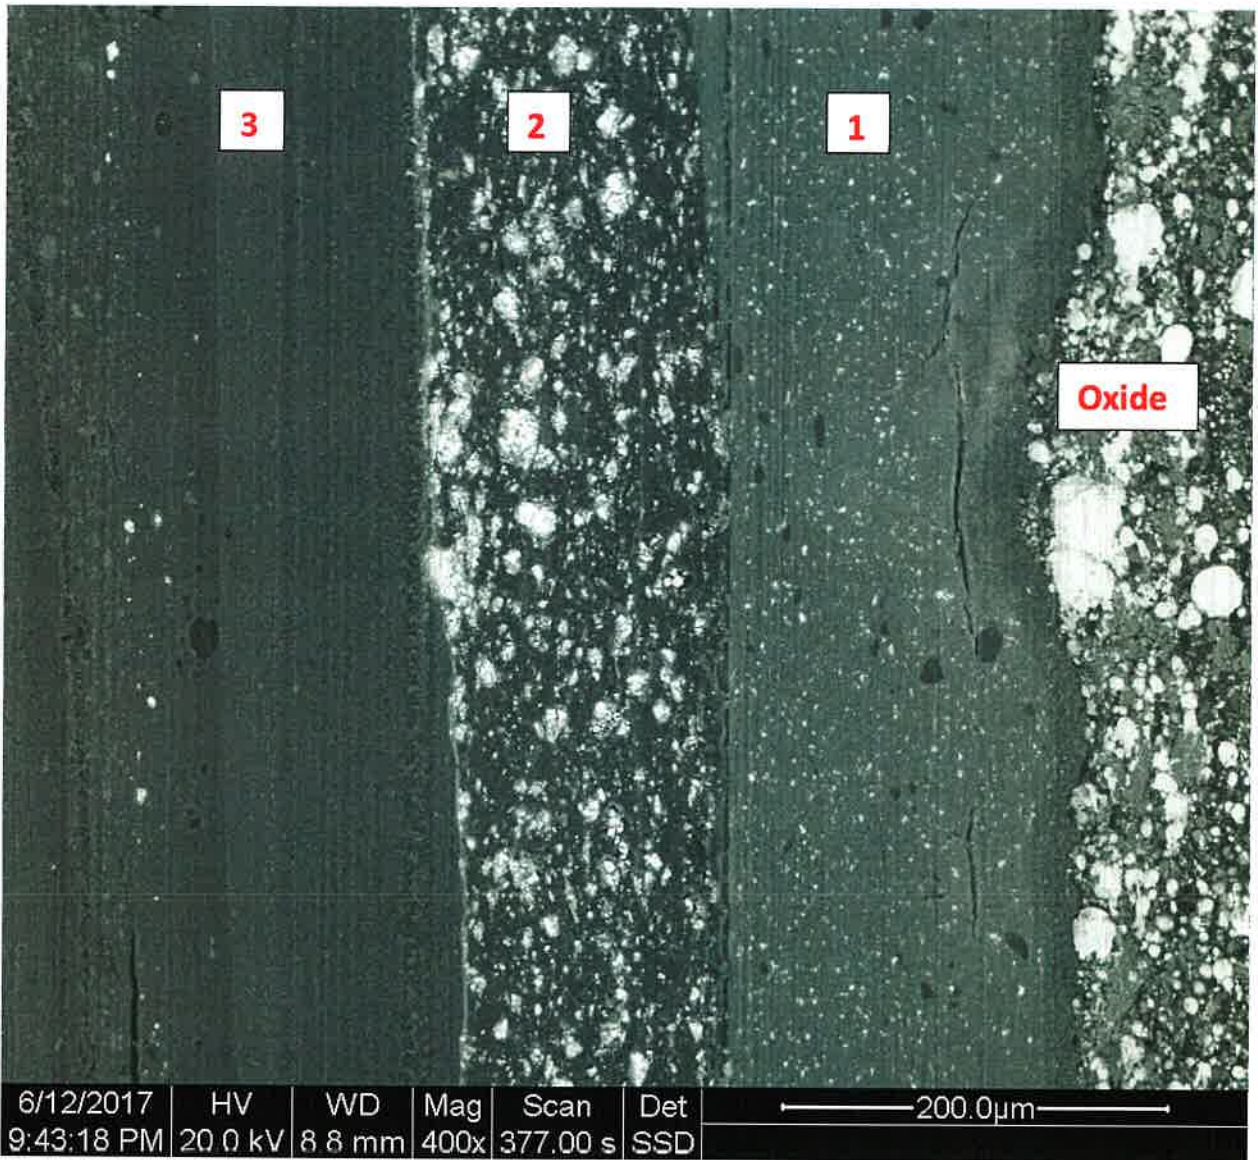
- Significant thickness differences in this sample relative to A and C.
- Missing exterior oxide "4"
