CRS - Color Variant (WHITE)
1500 Hours ASTM B117 Salt Spray

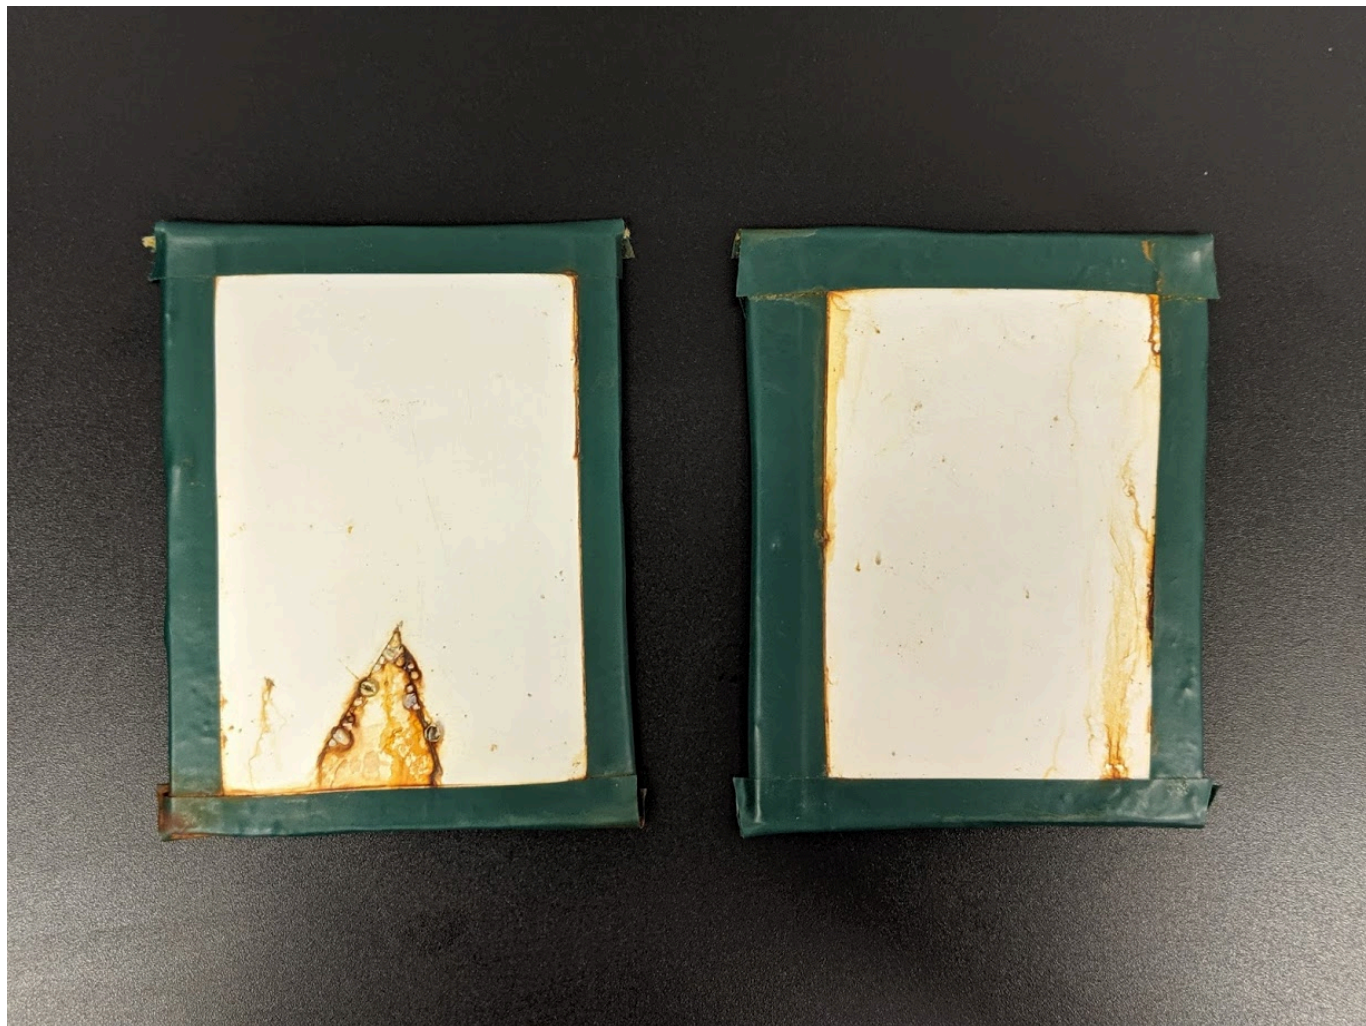
Left: Scribed panel shows bubbling and rust development in and around immediate area of scribe (V shape). No rust migration under coating, no peeling, coating stays in tact.

Right: Non-scribed panel. No signs of failure. Taped edges allowed some rust from uncoated edges to bleed through the tape. Coating shows no signs of failure.

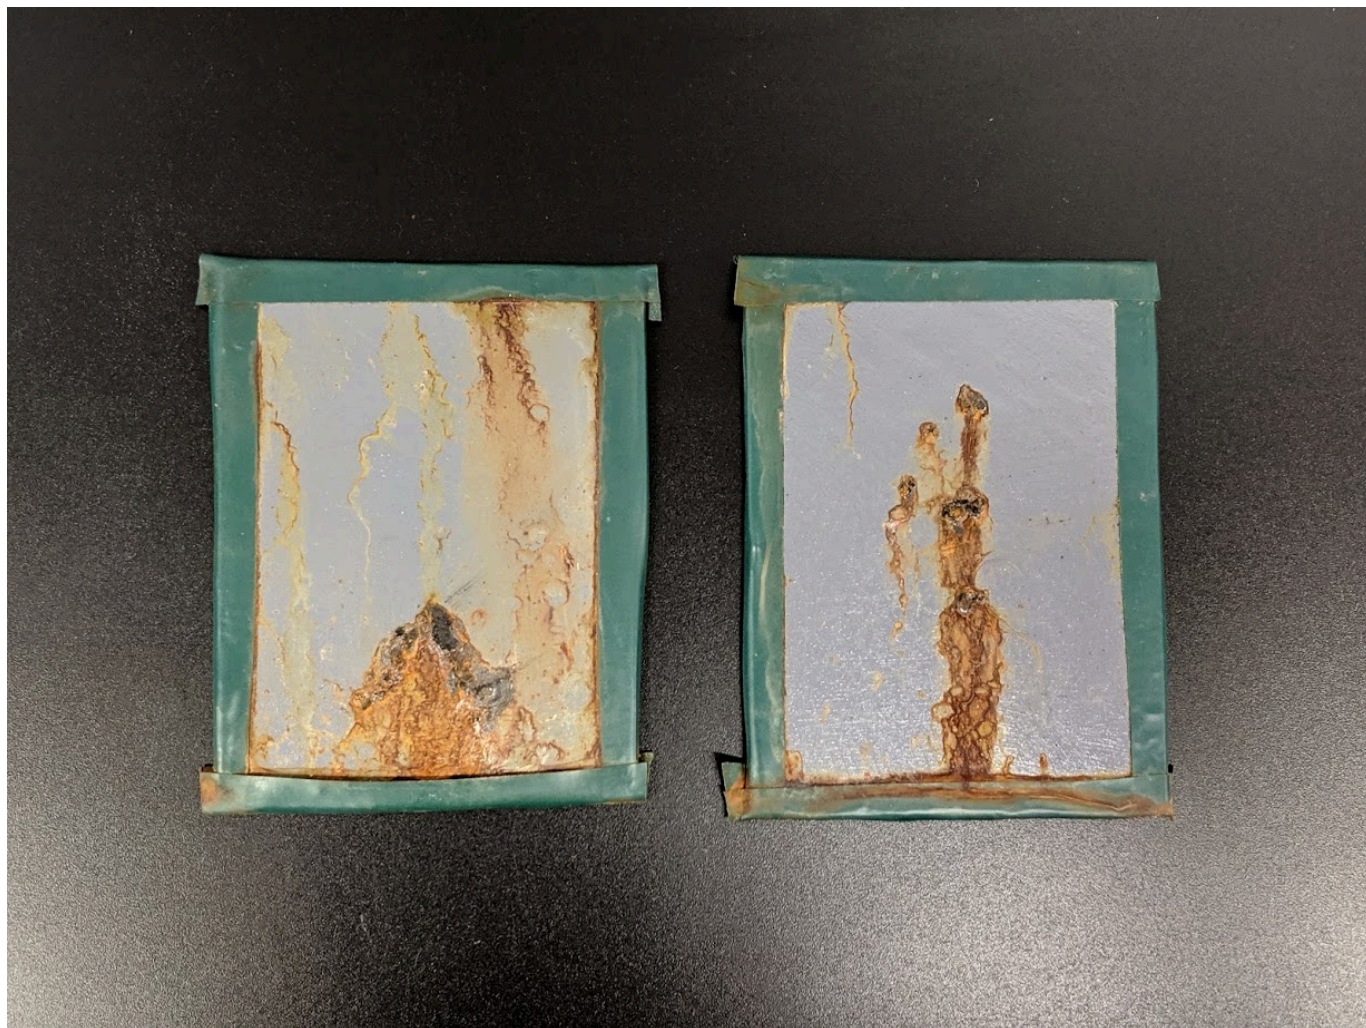
CRS - Color Variant (GRAY)
1500 Hours ASTM B117 Salt Spray

Left: Scribed panel shows bubbling and rust development in and around immediate area of scribe (V shape). No rust migration under coating, no peeling, coating stays in tact. All rust bleed on the coating is from under taped, uncoated edges.

Right: Non-scribed panel with several pinholes cut into the center area. Taped edges allowed significant rust from uncoated edges to bleed through the tape. Coating shows no failure apart from slight bubbling and rust within areas where pinholes were cut. No rust migration.
