Intrepid Potash 2013 Carlsbad New Mexico

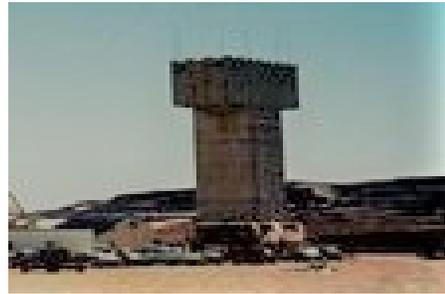
In November 2013 there was crucial FRP repair work to be done at the elevator shaft structure to reinforce the decay of the spalling concrete and metal structures. An FRP company was called to repair the vertical part of the T structure as well as a contractor to re-coat the structure because the previous coating had failed. Both of these issues could be improved and fixed with the use of C2M and H2Poxy-A.

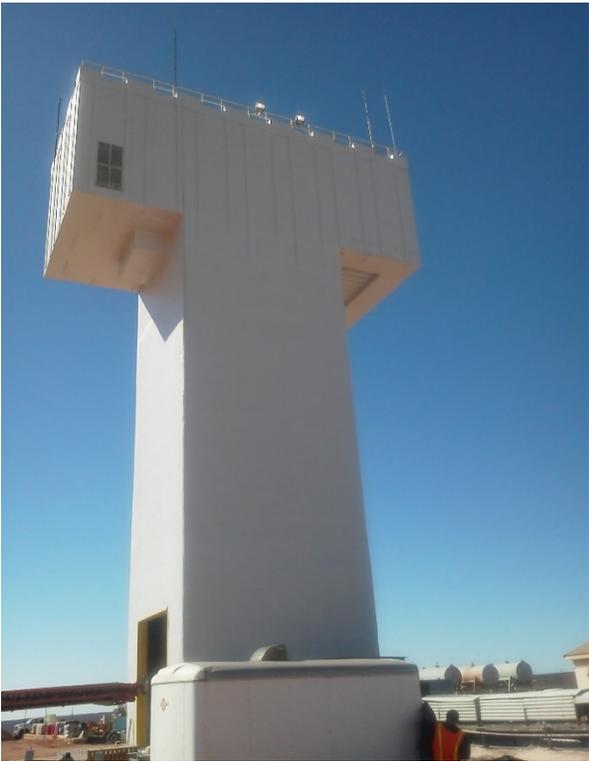
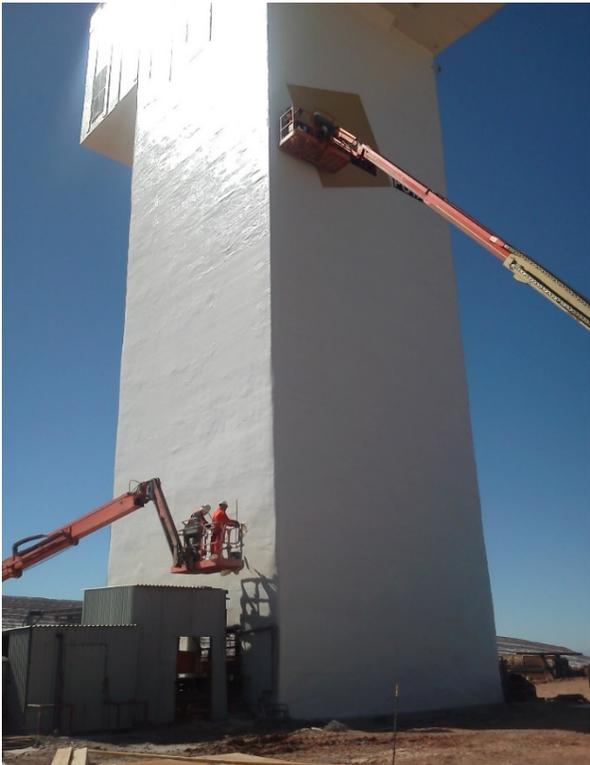
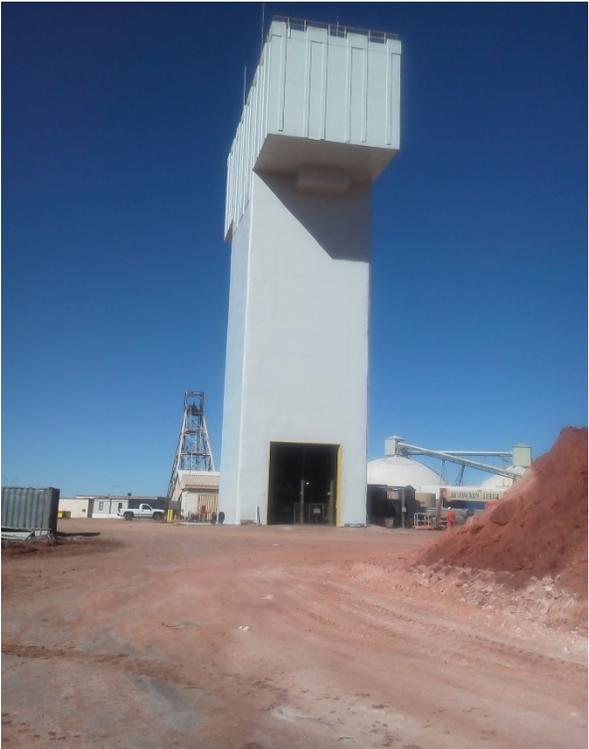
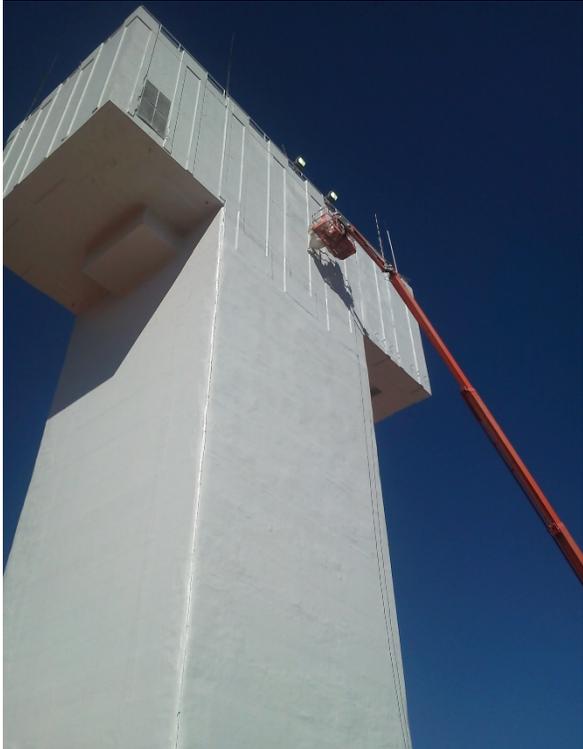
Working around the clock, the project was finished by the deadline.
